Final Report: LED 555 Timer

1. Plan of Record

a. Purpose

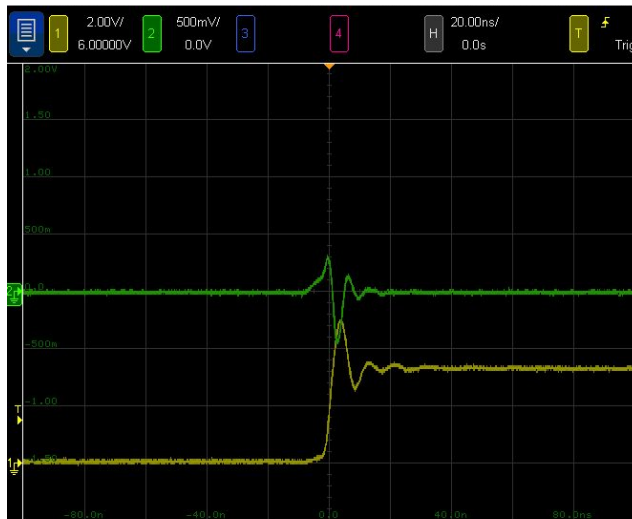
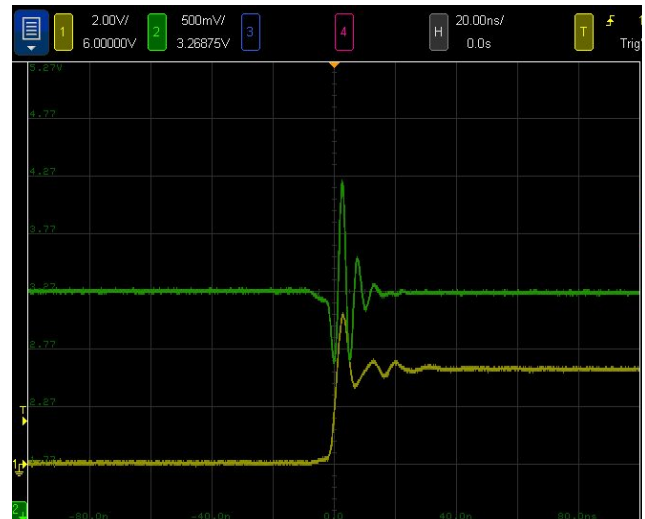
The right image to the left shows the trigger before adding the decoupling capacitors. We expected to see the switching noise drop upon adding the capacitors. The signal is being triggered on the rise of the 555 output, and the difference between the noise on the right image is significantly larger than the left image. The left image includes the use of decoupling capacitors. We are using the 100 kHz 555 calculated from the full on and off duty cycle of the chip. From analyzing the images to the left, it can be estimated, the rise time is very small, approximately five nanoseconds.

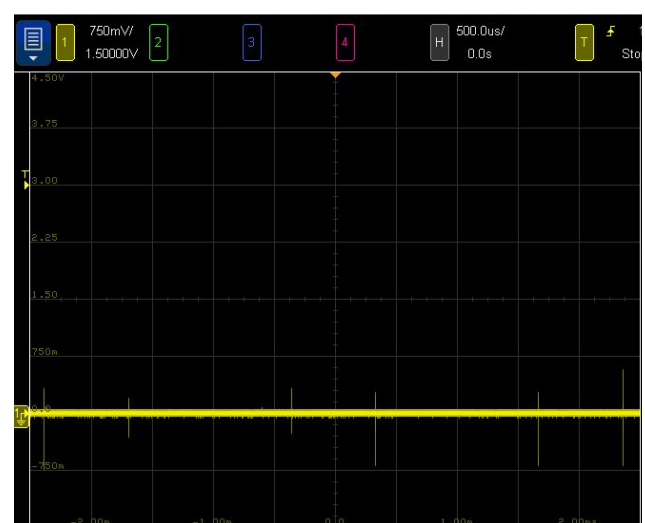
The four images above compare and contrast the Golden Board (in yellow on the right) and the revision 2 board (green on the left). We thought we would see a considerable difference in noise, but found it to be somewhat similar. One thing we would change would be to use the same time scaling and voltage scaling with the same vertical and horizontal offsets in order to get a better visual representation of the two signals. The top two images compare the Qlow signal and the bottom two images compare the Qhigh signal. On all four images, 1V peak to peak noise can be seen which differs from what we expected, but helped to propel our thinking as to why the two signals are very comparable.
